Upside-Down Barge

"Artificial Reef Stability Assessment Survey"

"Upside Down Barge"

Date of Survey: May 22, 2004

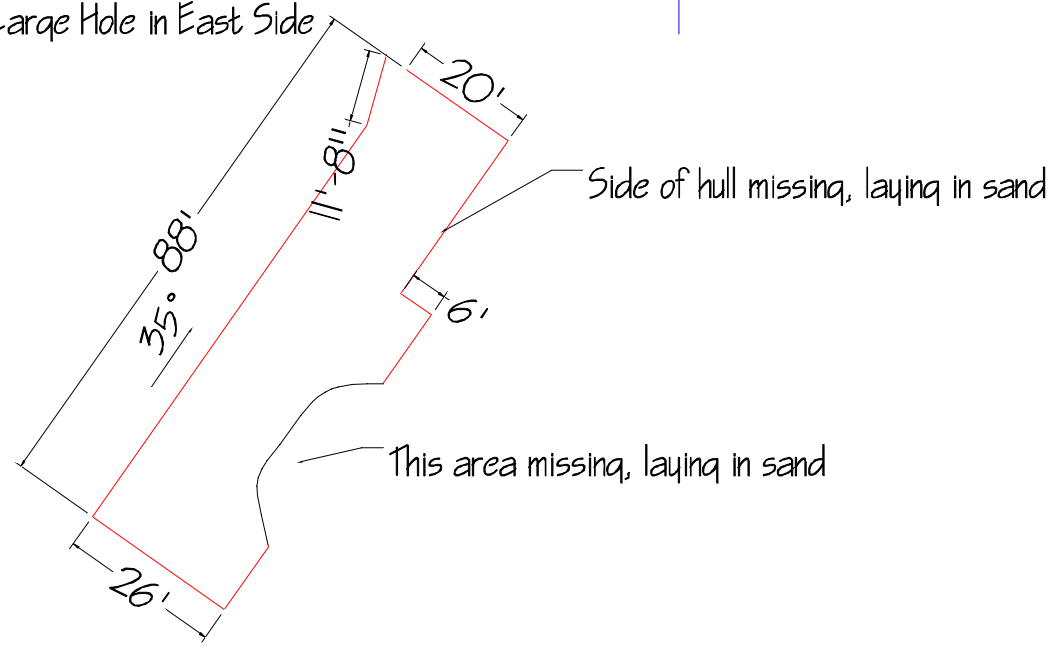
"Upside Down Barge"
 Mapped 05-22-04
 Drawn by BS 11-28-04

Collapse: 75% of the Hull plating has collapsed. The South end has broken off. 90% of the sides are missing.

Scattering: There are several pieces of the Hull laying in close proximity to the Barge. South and West sides.

Disintegration: Much disintegration. Very jagged edges.

Additional Observations: In spite of there being almost nothing left of this barge, the remaining structure is heavily encrusted with Benthic organisms. A beam on the Southeast corner has several large Anemones on it.
