Martin County's Nearshore Mitigation Reefs Year-6 Monitoring Report

by Lee E. Harris, Ph.D., P.E., Kerry L. Dillon, and Laura Herren

March 2007

2006 Annual Monitoring Report

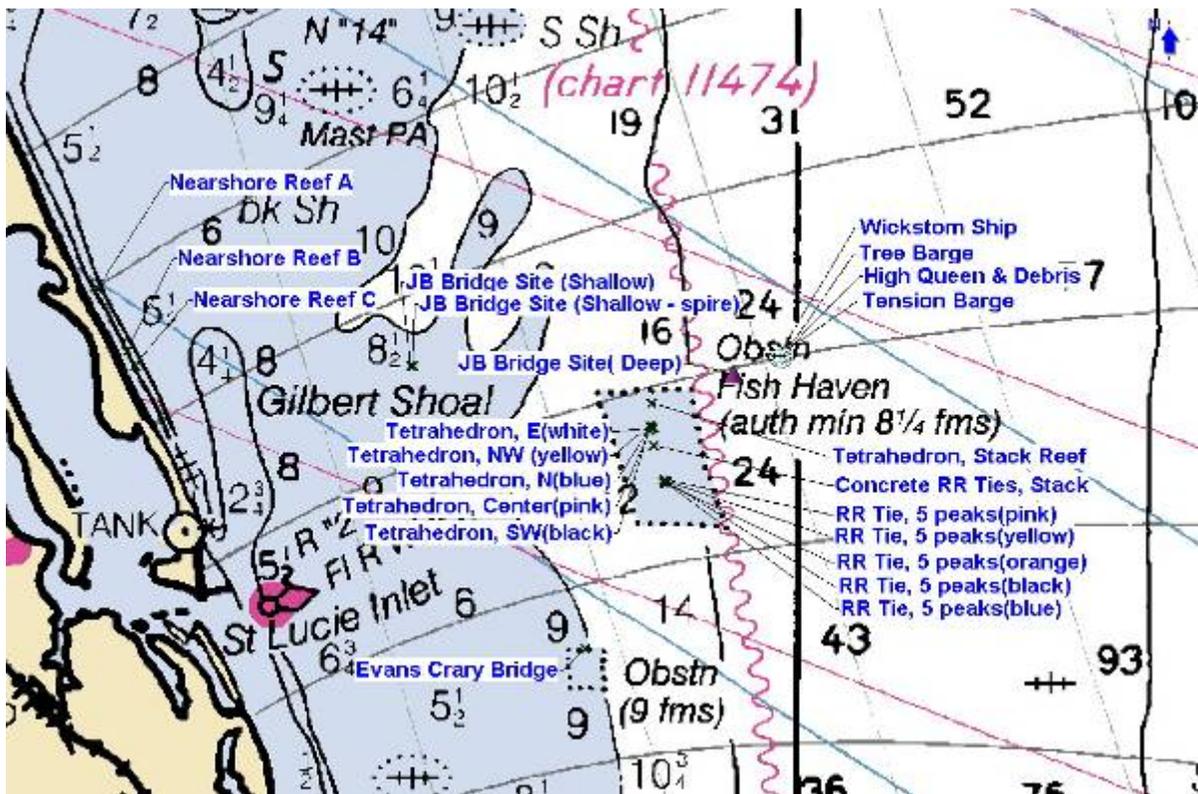
Figure 2. Artificial Reefs deployed 2000 to 2005 offshore Martin County

Some of the bridge components were used to create the three shallow water mitigation reefs close to the Stuart and Jensen Beach shorelines in water depths of 10-20 feet, while the larger bridge sections and the majority of the materials were deployed in the Ernst permitted reef site in water depths of 60-70 feet. The Ernst permitted reef site is located approximately 5 miles offshore Martin County, Florida, with GPS Coordinates: N27 09.346 / W80 03.368 (center of the reef at the high section of the reef materials). These artificial reef sites are shown in Figure 2, along with all the other artificial reef deployments made offshore Martin County from 2000 through 2005.

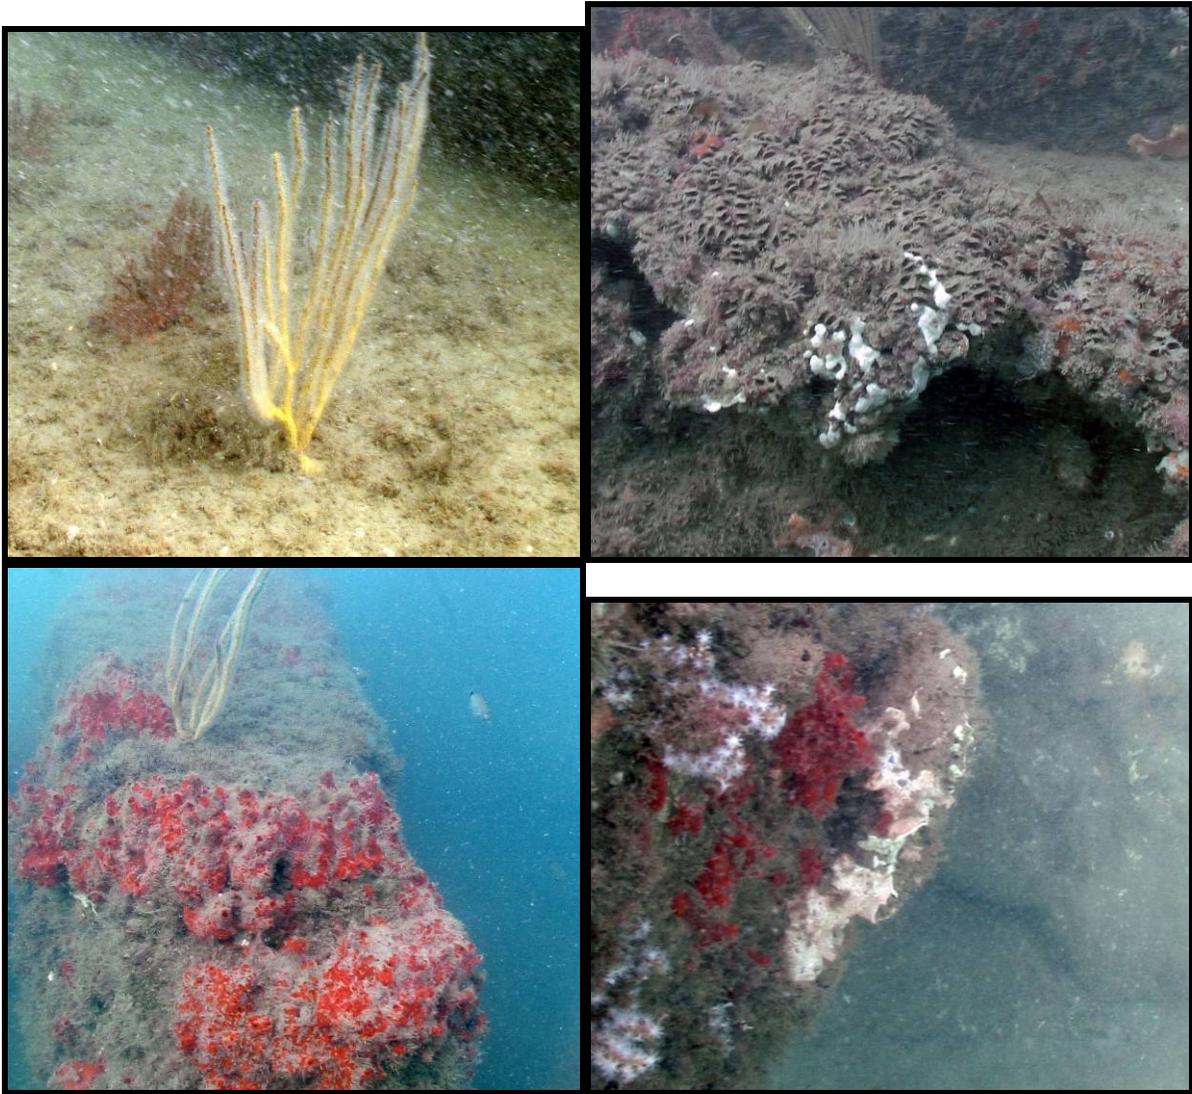
Figure 3. Representative benthic growth on Martin County Mitigation Reef A

On December 27, 2006 divers spent 75 minutes on Mitigation Reef A photographing benthic invertebrates and macroalgae. Sabellariid wormrock reef was photographed on Mitigation Reef A on June 30, 2006, and at that time, there appeared to be several well-established colonies. Wormrock was absent from the site on December 27, 2006. One individual of *Oculina diffusa* was impacted by monofilament fishing line. Benthic species listed in Table 4 were identified using the roving diver technique on December 27, 2006. Representative benthic species from Mitigation Reef A are shown in Figure 3.

a) upper left - yellow sea whip (*Leptogorgia virgulata*) and regal sea fans (*Leptogorgia hebes*), b) upper right - sabellariid wormrock reef (*Phragmatopoma* spp.) found in June 2006, c) lower left - yellow sea whip and unidentified orange sponge, and d) lower right - white telesto (*Carijoa riisei*).

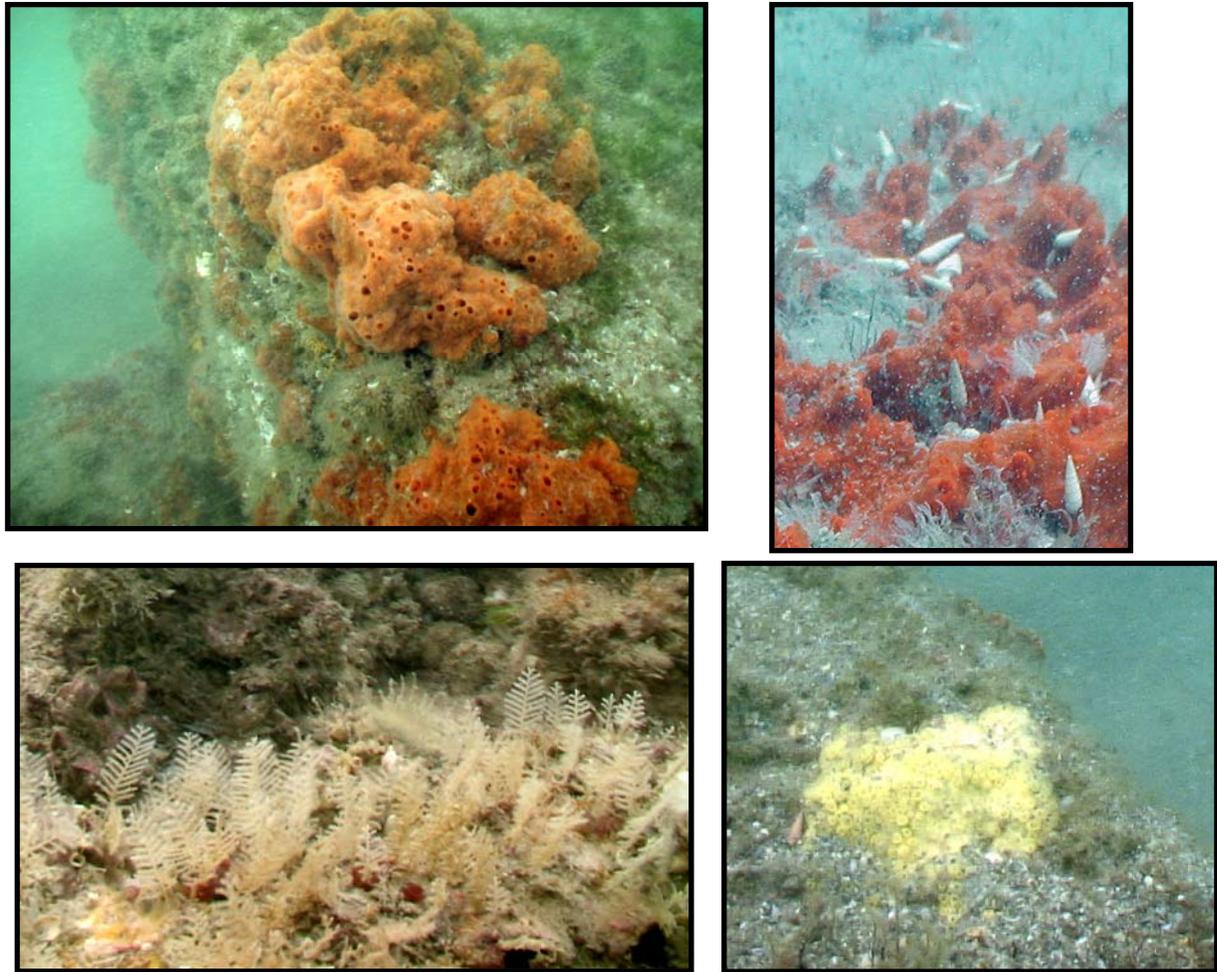
Figure 4. Representative benthic growth on Martin County Mitigation Reef C

A dramatic change in the benthic community documented in May 2004 was observed in December 2006. A greater variety of attached macroalgae was documented in 2004 than 2006. The green algae (*Codium*, *Caulerpa*, and *Halimeda*) documented in 2004 were replaced by *Bryopsis pennata* by December 2006. Most importantly, high concentration of the exotic invasive green alga *Caulerpa brachypus* documented in May 2004 (pre-Hurricane Francis) was absent in December 2006. In May 2004, four genera of brown algae (*Sargassum*, *Dictyota*, *Spatoglossum*, and *Padina*) were documented. No brown algae were located during the 2006 survey. The number of species of red algae also decreased significantly by December 2006. One of the greatest transitions between 2004 and 2006 was the percent cover of sponges (especially *Pseudaxinella lunaecharta*). The abundance and species of

tunicates did not differ much between the 2004 and 2006 surveys. No sea urchins or sea cucumbers were documented on Mitigation Reef C during the December 2006 survey. Representative benthic species from Mitigation Reef C are shown in Figure 4.

a) upper left - orange sponge *Pseudaxinella lunaecharta*, b) lower left - feather plume hydroids *Aglaophenia latecarinata*, c) upper right - Eastern augers *Terebra salleana*, and d) lower right - unidentified yellow sponge.

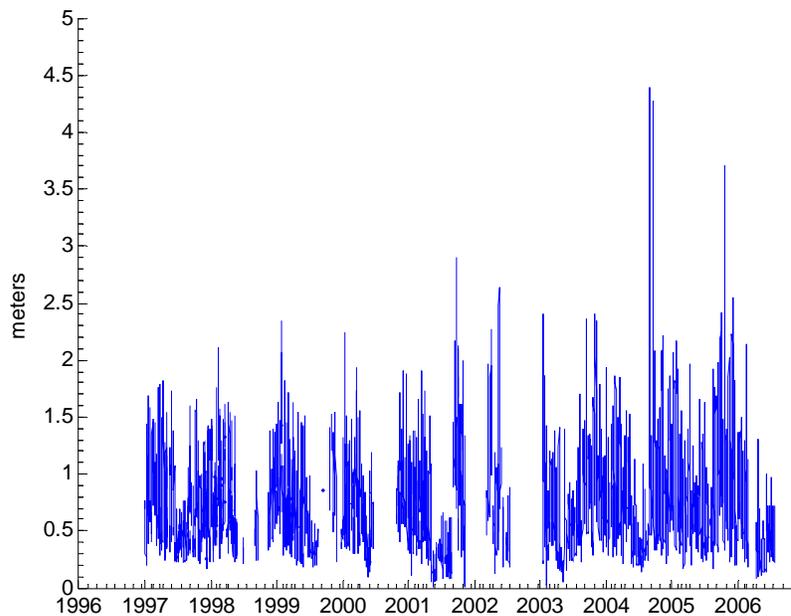
Figure 5. Significant Wave Height Data from Sebastian Inlet, FL (Harris and Flanary, 2007)

The Martin County coast was severely impacted by major hurricanes Frances (Cat.2) and Jeanne (Cat.3) in September 2004 and Hurricane Wilma (Cat.3) in October 2005, which produced the largest waves recorded along the central east coast of Florida in the past 10 years. Wave data from offshore Sebastian Inlet measured in water depth of 28 feet at a location approximately 50 miles north of the mitigation reefs are shown in Figure 5, with the three largest significant wave height peaks occurring during the 2004 and 2005 hurricanes being much greater than for any other time periods. Extremely strong currents were also measured during the 2004 and 2005 hurricanes (Harris and Flanary, 2007).

Data from co-located ADCP current meters with directional wave data capability.
