Upside-Down Barge

"Artificial Reef Stability Assessment Survey"

"Upside Down Barge"

Date of Survey: May 22, 2004

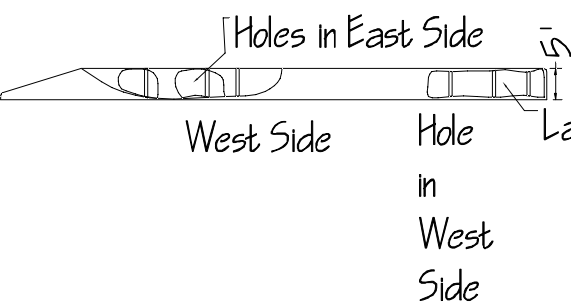
"Upside Down Barge"
 Mapped 05-22-04
 Drawn by BS 11-28-04

General Condition of Material: Very Poor

Collapse: 75% of the Hull plating has collapsed. The South end has broken off. 90% of the sides are missing.

Disintegration: Much disintegration. Very jagged edges.

Additional Observations: In spite of there being almost nothing left of this barge, the remaining structure is heavily encrusted with Benthic organisms. A beam on the Southeast corner has several large Anemones on it.
