8 Wickstrom Artificial Reef

8.1 History of the Wickstrom Artificial Reef

8.2 Wickstrom Orientation and Components

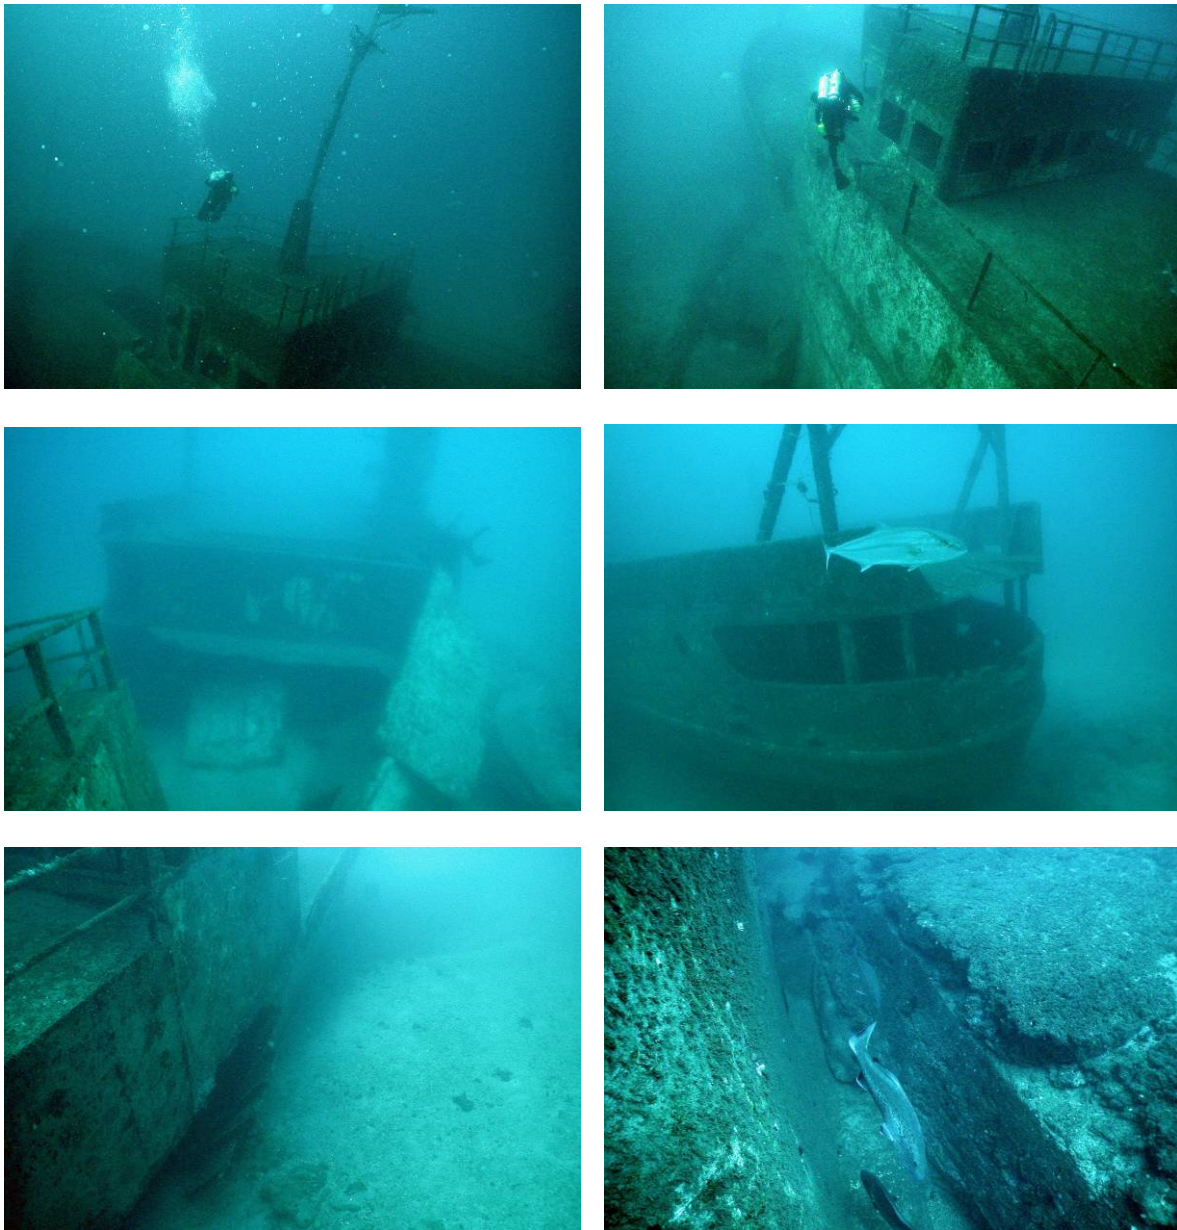
Figure 16. Wickstrom June 3, 2006 Photographs

The Wickstrom deployment was with the ship upright and the deck level, with no noticeable listing. The bow faced southerly at 190° and the stern faced northerly at 10°. Due to the 2004 and 2005 hurricanes, the ship is now completely broken in half just aft of the superstructure. The bow now faces SE at 120°, while the stern faces NW at 320°. The entire hull along the chine and keel has sawed into the limestone substrate approximately 6 feet deep. Scour exists along the length of the ship approximately 6-8 feet deeper than the surrounding natural sand/shell seafloor.

Photographs taken in 2006 (2007 photographs were poorer quality) of the Wickstrom are shown in Figure 16, which show the damages due to the hurricanes. The bottom two photos show the cutting into the limestone bottom that has occurred. The only other major change noted in 2007 was the falling over of the masthead, so that the highest point is now at a depth of 133 feet.
